**Flood Control Project Maintenance
Levee Inspections**
LMA District Cover Sheet
Spring 2018 Levee Inspection Results

Reclamation District No. 0150 Merrit Island

Spring 2018 Levee Inspection Results

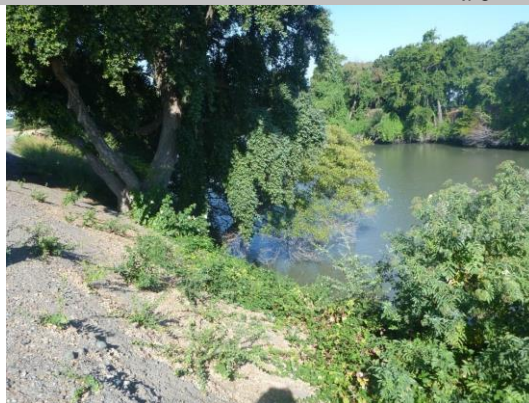
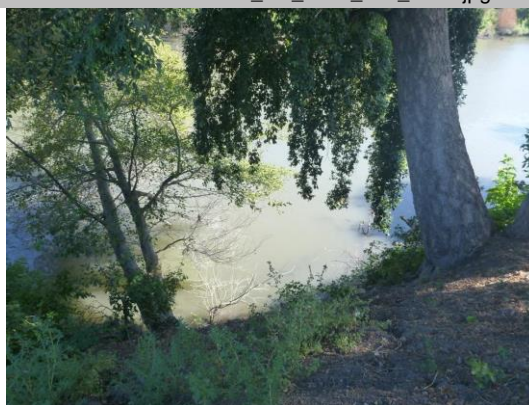
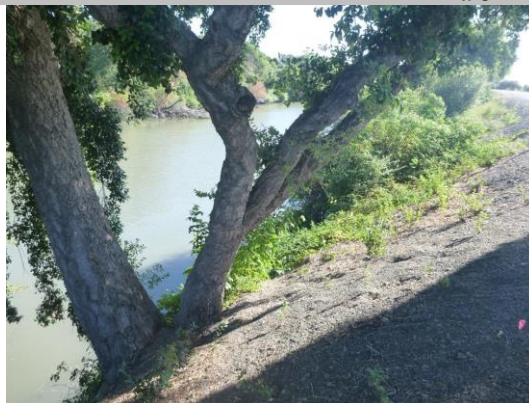
LM Start	2.29	Rating **	A/W	Issue No.	37
LM End	2.30	Issue Type +	Ma	Location *	
Category	Supplemental			GPS Latitude/Longitude	
				Start	End
Item	2017 Storm Damage			38.354103 °	38.354211 °
				-121.564850 °	-121.564631 °
DWR ID	DWR_RD0150_03_f_2017_37				
Comment Code					
Inspector Comment					
Levee Evaluation Comments					
Description:Instability, cracking, and erosion were observed on the waterside levee slope on the east (left) bank of Elk Slough. The site is approximately 75 feet long. See attached pages for photos.					
Site ID No:294					
Site Designation:LMA-120					
Repair Type: Erosion					
Rating:Area of Concern					
Field Date:7/19/2017					
Notes: Area of concern because erosion is not too far into the levee prism and looks similar to the rest of the levee outside of the site.					
Crown is a paved road.

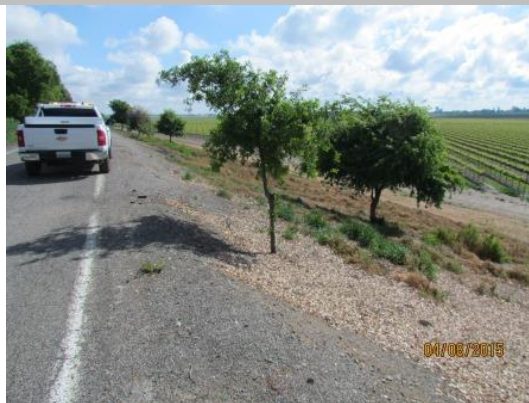
Photo 2 of 4 : SP_2018_RD0150_17_78_20180301_00074.jpg

LM Start	2.31	Rating **	M	Issue No.	78 (cont)	
LM End	2.31	Issue Type +	Ma	Location *	LS	
Category	Earthen Levee			GPS Latitude/Longitude		
				Start	End	
Item	Trim / Thin Trees			38.354286 °	38.354286 °	
				-121.564494 °	-121.564494 °	
DWR ID	DWR_RD0150_03_s_2012_78					
Comment Code						
T2 : Thin trees to allow visibility of the ground and room to flood fight.						
Inspector Comment						
New tree was planted on the landside slope. Remove trees smaller than 4-inches in diameter at chest height.

Updated picture of the trees on the landside of the levee during spring 2015 inspection.

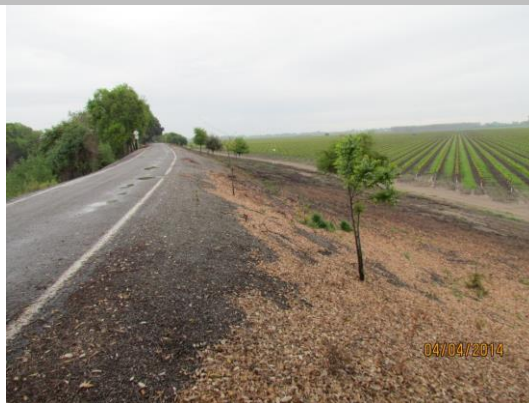
Photo 4 of 4 : SP_2018_RD0150_17_78_20180301_00076.jpg

View of the newly planted tree on the landside slope of the levee during spring 2014 inspection.

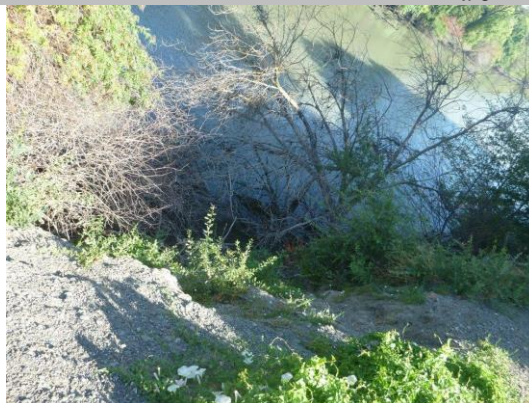
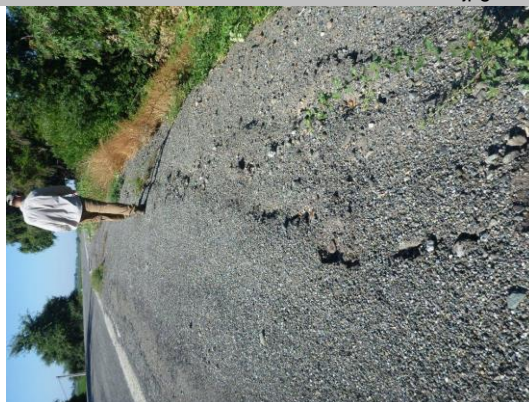
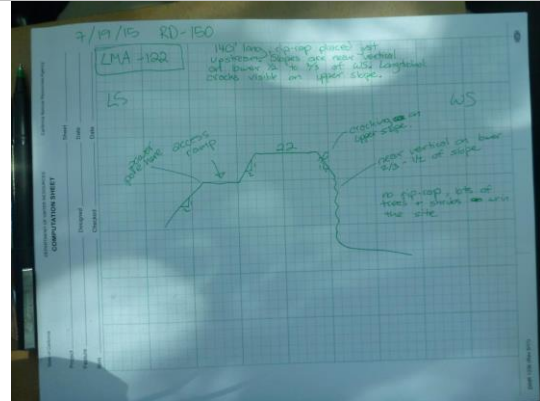
Comment Code					
Inspector Comment					
Levee Evaluation Comments					
Description:On 11 and 15 January 2017, waterside instability and cracking were observed on the east (left) bank of Elk Slough. The site is approximately 80 feet long and 5 to 10 feet down from the levee crest. See attached pages for photos.					
Site ID No:296					
Site Designation:LMA-122					
Repair Type: Stability					
Rating:Critical					
Field Date:7/19/2017					
Notes: Crown is a paved road. Serious because erosion cuts into levee prism significantly (lower 2/3 - 1/2 is near vertical) and longitudinal cracking observed above erosion, but damage does not extend into crown.

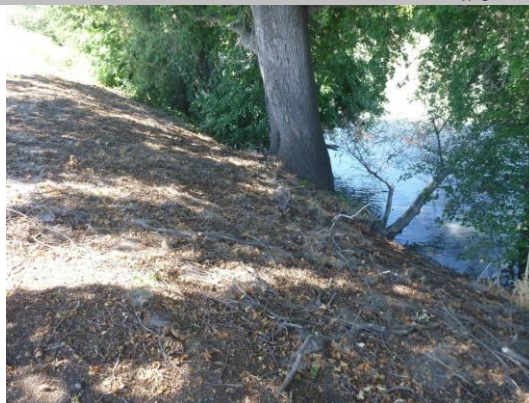
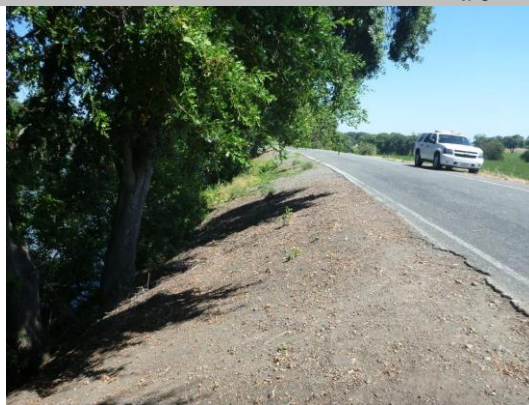
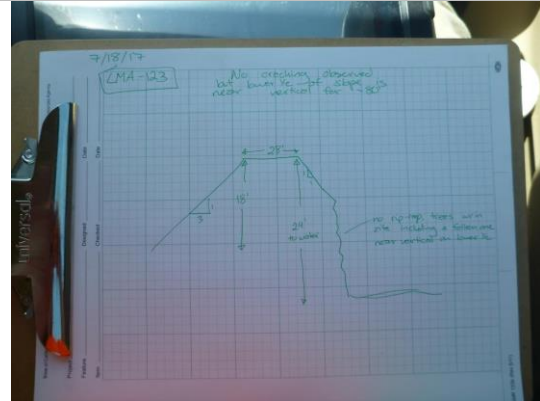
Comment Code					
Inspector Comment					
Levee Evaluation Comments					
Description:On 11 and 15 January 2017, waterside instability and cracking were observed on the east (left) bank of Elk Slough. The site is approximately 75 feet long and 5 to 10 feet down from the levee crest. See attached pages for photos					
Site ID No:297					
Site Designation:LMA-123					
Repair Type: Stability					
Rating:Area of Concern					
Field Date:7/18/2017					
Notes: Crown is a paved road. 20 ft of cracking observed maximum within the site, but lower 1/4 of slope is near vertical. Lower priority because it is not too much worse than the surrounding levees.

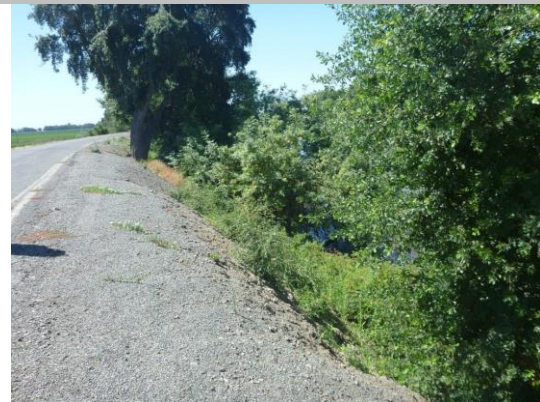
Comment Code					
Inspector Comment					
Levee Evaluation Comments					
Description:On 11 and 15 January 2017, waterside instability and cracking were observed on the east (left) bank of Elk Slough. The site is approximately 80 feet long and 5 to 10 feet down from the levee crest. See attached pages for photos.					
Site ID No:298					
Site Designation:LMA-124					
Repair Type: Stability					
Rating:Area of Concern					
Field Date:7/18/2017					
Notes: No cracking observed, but there is runoff erosion along the entire WS slope here. Crown is a paved road. Area of concern because erosion was caused by runoff and was less severe than other sites along Elk Slough.

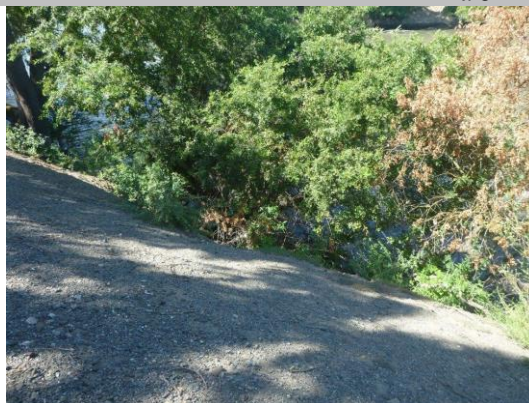
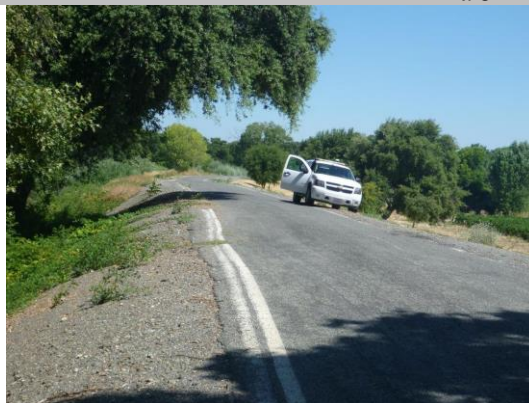
LM Start	2.80	Rating **	A/W	Issue No.	53
LM End	2.81	Issue Type +	Ma	Location *	
Category	Supplemental			GPS Latitude/Longitude	
				Start	End
Item	2017 Storm Damage			38.360367 °	38.360544 °
				-121.561592 °	-121.561683 °
DWR ID	DWR_RD0150_03_f_2017_53				
Comment Code					
Inspector Comment					
Levee Evaluation Comments					
Description:On 11 January 2017, waterside instability and cracking were observed on the east (left) bank of Elk Slough. The site is approximately 70 feet long and 12 feet down from the levee crest. See attached pages for photos					
Site ID No:299					
Site Designation:LMA-125					
Repair Type: Stability					
Rating:Area of Concern					
Field Date:7/18/2017					
Notes: Crown is a paved road. Cracking on upper 1/3 of slope. Lower 1/2 of slope is near vertical. Area of concern because erosion is less severe than other sites along Elk Slough.

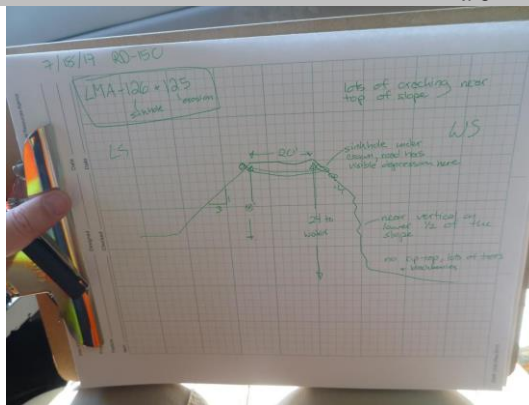
Photo 3 of 3 : LEVAL_SP_2018_299_2108.jpg

LM Start	2.80	Rating **	A/W	Issue No.	53 (cont)
LM End	2.81	Issue Type +	Ma	Location *	
Category	Supplemental			GPS Latitude/Longitude	
				Start	End
Item	2017 Storm Damage			38.360367 °	38.360544 °
				-121.561592 °	-121.561683 °
DWR ID	DWR_RD0150_03_f_2017_53				
Comment Code					
Inspector Comment					
Levee Evaluation Comments					
Description:On 11 January 2017, waterside instability and cracking were observed on the east (left) bank of Elk Slough. The site is approximately 70 feet long and 12 feet down from the levee crest. See attached pages for photos					
Site ID No:299					
Site Designation:LMA-125					
Repair Type: Stability					
Rating:Area of Concern					
Field Date:7/18/2017					
Notes: Crown is a paved road. Cracking on upper 1/3 of slope. Lower 1/2 of slope is near vertical. Area of concern because erosion is less severe than other sites along Elk Slough.

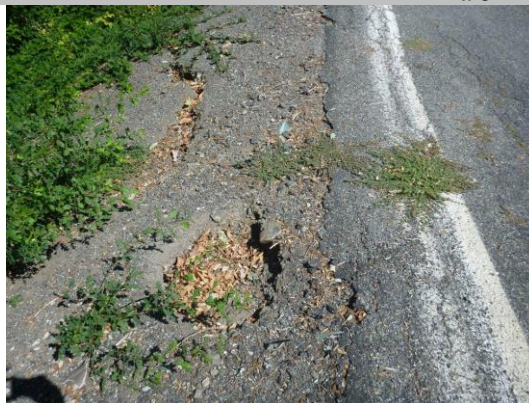
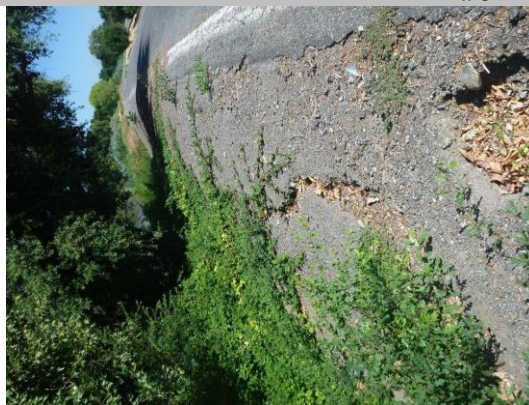
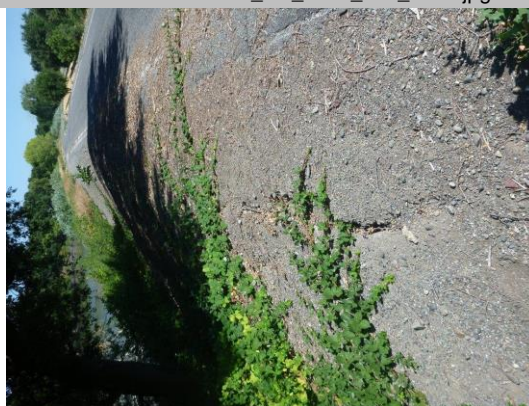
LM Start	2.80	Rating **	M	Issue No.	79
LM End	2.80	Issue Type +	Ma	Location *	
Category	Supplemental			GPS Latitude/Longitude	
				Start	End
Item	2017 Storm Damage			38.360372 °	38.360397 °
				-121.561594 °	-121.561606 °
DWR ID	DWR_RD0150_03_f _ 2017_79				
Comment Code					
Inspector Comment					
Levee Evaluation Comments					
Description:On 7 February 2017, a sinkhole 3 feet wide by 3 feet deep was observed at the levee crest. See attached pages for photos.					
Site ID No:300					
Site Designation:LMA-126					
Repair Type: Stability					
Rating:Area of Concern					
Field Date:7/18/2017					
Notes: Sinkhole os present on both sides of crown and crown has a dip of about 1 ft on the WS half. Crown is a paved road here. Sink hole appears to be caused by a rodent hole so it was rated lower priority because it is a general maintenance issue. See LMA-125 for cross section.

Comment Code						
Inspector Comment						
Levee Evaluation Comments						
Description:On 7 February 2017, a sinkhole 3 feet wide by 3 feet deep was observed at the levee crest. See attached pages for photos.						
Site ID No:300						
Site Designation:LMA-126						
Repair Type: Stability						
Rating:Area of Concern						
Field Date:7/18/2017						
Notes: Sinkhole os present on both sides of crown and crown has a dip of about 1 ft on the WS half. Crown is a paved road here. Sink hole appears to be caused by a rodent hole so it was rated lower priority because it is a general maintenance issue. See LMA-125 for cross section.

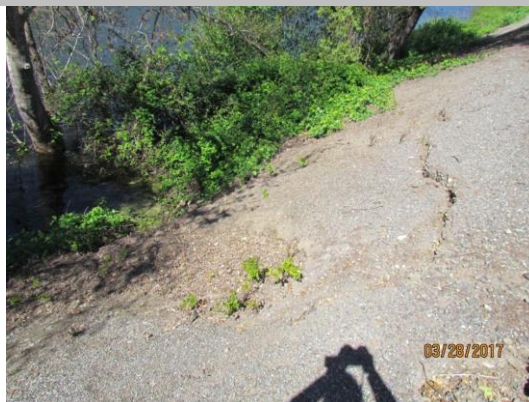
Photo 1 of 2 : SP_2018_RD0150_17_35_20180301_00020.jpg

LM Start	2.80	Rating **	A/W	Issue No.	35
LM End	2.80	Issue Type +	Ma	Location *	WS
Category	Earthen Levee			GPS Latitude/Longitude	
				Start	End
Item	Erosion / Bank Caving			38.360432 °	38.360432 °
				-121.561644 °	-121.561644 °
DWR ID	DWR_RD0150_03_s_2013_35				
Comment Code					
E2 : Schedule repair of erosion site prior to the next inspection.					
Inspector Comment

Updated picture of the erosion on the waterside of the levee during spring 2017 inspection.

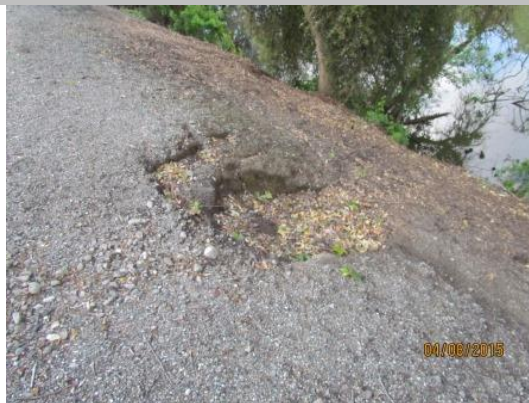
Photo 2 of 2 : SP_2018_RD0150_17_35_20180301_00021.jpg

LM Start	2.80	Rating **	A/W	Issue No.	35 (cont)	
LM End	2.80	Issue Type +	Ma	Location *	WS	
Category	Earthen Levee			GPS Latitude/Longitude		
				Start		End
Item	Erosion / Bank Caving			38.360432 °		38.360432 °
				-121.561644 °		-121.561644 °
DWR ID	DWR_RD0150_03_s_2013_35					
Comment Code						
E2 : Schedule repair of erosion site prior to the next inspection.						
Inspector Comment

View of the erosion on the waterside of the levee during spring 2015 inspection.

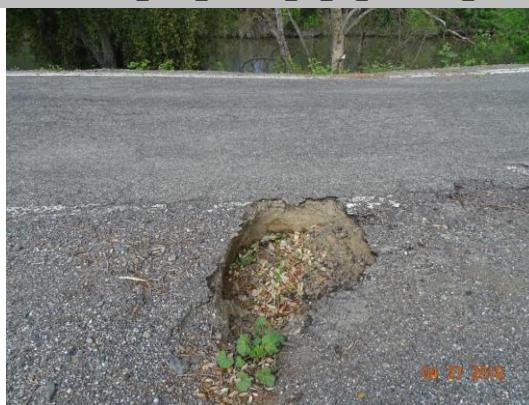
Photo 1 of 2 : SP_2018_RD0150_17_71_20180430_00198.jpg

LM Start	2.81	Rating **	U	Issue No.	71
LM End	2.81	Issue Type +	Ma	Location *	LS
Category	Earthen Levee			GPS Latitude/Longitude	
				Start	End
Item	Animal Control			38.360477 °	38.360477 °
				-121.561625 °	-121.561625 °
DWR ID	DWR_RD0150_03_s_2017_71				
Comment Code					
A3 : No rodents visible, but rodent burrows visible; need to backfill and compact or grout burrows.					
Inspector Comment

Rodent hole landside looking west.

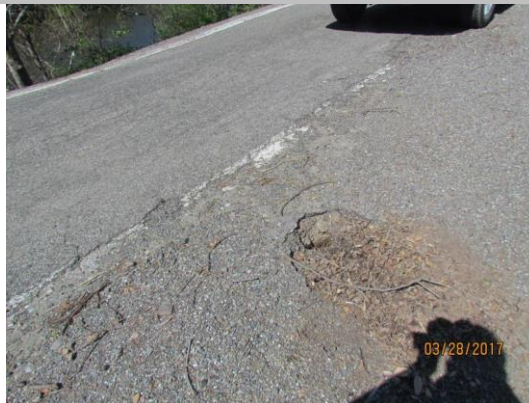
Photo 2 of 2 : SP_2018_RD0150_17_71_20180301_00068.jpg

LM Start	2.81	Rating **	U	Issue No.	71 (cont)
LM End	2.81	Issue Type +	Ma	Location *	LS

View of a rodent hole on the landside shoulder of the levee looking upstream.

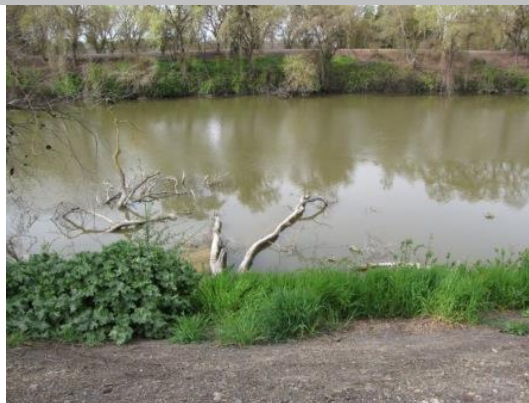
Photo 1 of 1 : SP_2018_RD0150_17_17_20180301_00007.jpg

LM Start	2.82	Rating **	M	Issue No.	17
LM End	2.82	Issue Type +	Ma	Location *	WS
Category	Earthen Levee			GPS Latitude/Longitude	
				Start	End
Item	Encroachments			38.360621 °	38.360621 °
				-121.561762 °	-121.561762 °
DWR ID	DWR_RD0150_03_s_2012_17				
Comment Code					
TR : Tree or limb					
Inspector Comment					
Remove down tree on the waterside toe of the levee.

View of tree stumps and downed tree on the waterward slope.

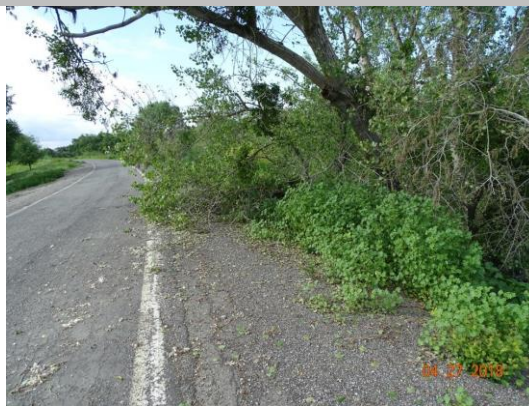
Photo 1 of 1 : SP_2018_RD0150_17_86_20180430_00199.jpg

LM Start	2.95	Rating **	M	Issue No.	86
LM End	2.95	Issue Type +	Ma	Location *	WS
Category	Earthen Levee			GPS Latitude/Longitude	
				Start	End
Item	Encroachments			38.362431 °	38.362431 °
				-121.562265 °	-121.562265 °
DWR ID	DWR_RD0150_03_s_2018_86				
Comment Code					
TR : Tree or limb					
Inspector Comment					
Remove downed tree on waterside slope.

Downed tree waterside looking southwest.

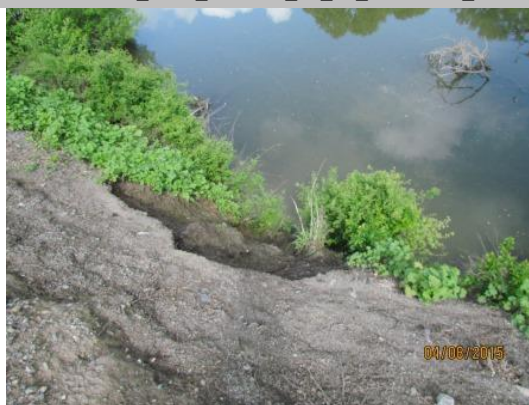
Photo 1 of 2 : SP_2018_RD0150_17_40_20180301_00033.jpg

LM Start	3.31	Rating **	M	Issue No.	40
LM End	3.31	Issue Type +	Ob	Location *	WS
Category	Earthen Levee			GPS Latitude/Longitude	
				Start	End
Item	Erosion / Bank Caving			38.363008 °	38.363008 °
				-121.556751 °	-121.556751 °
DWR ID	DWR_RD0150_03_s_2013_40				
Comment Code					
E2 : Schedule repair of erosion site prior to the next inspection.					
Inspector Comment

Updated picture of the erosion on the waterside of the levee during spring 2015 inspection.

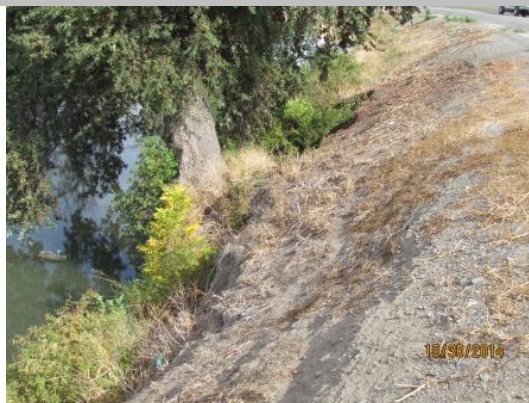
Photo 2 of 2 : SP_2018_RD0150_17_40_20180301_00034.jpg

LM Start	3.31	Rating **	M	Issue No.	40 (cont)
LM End	3.31	Issue Type +	Ob	Location *	WS

Updated picture of the erosion on the waterside of the levee looking upstream during fall 2014 inspection.

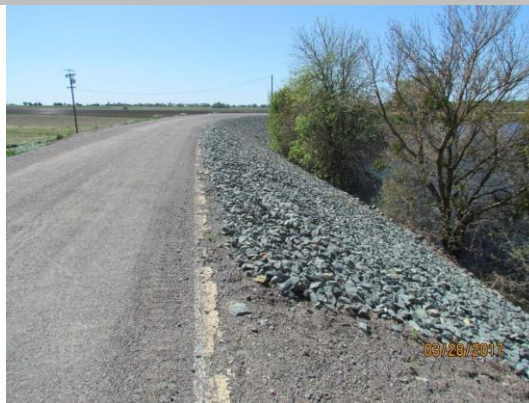
Photo 1 of 1 : SP_2018_RD0150_17_76_20180301_00072.jpg

LM Start	3.37	Rating **	A/W	Issue No.	76
LM End	3.45	Issue Type +	Ma	Location *	WS
Category	Earthen Levee			GPS Latitude/Longitude	
				Start	End
Item	Riprap Revetments			38.363380 °	38.364325 °
				-121.555715 °	-121.555330 °
DWR ID	DWR_RD0150_03_s_2017_76				
Comment Code					
Inspector Comment					
LMA or the pipe owner has placed new riprap on the waterside slope.

View of the new riprap on the waterside slope of the levee looking downstream. Spring 2017

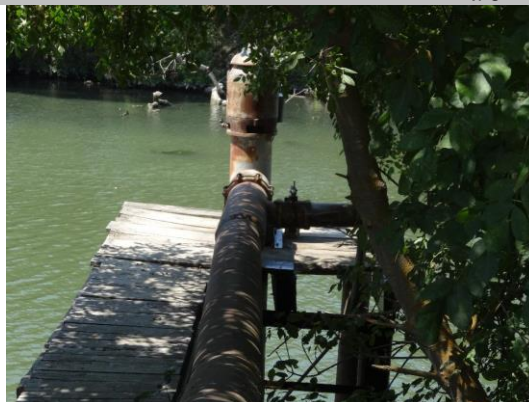
Photo 2 of 3 : UCIP_SP_2018_51467_35012.jpg

Comment Code					
Inspector Comment					
FS_ID:51467 DS_ID:22439 EP_NO: N/A Repair Type: Urgent Crossing Status: Found UCIP Comments: 03/30/2017 Riprap laid around pipe on WS slope. Source of erosion has not been addressed, nor has LS toe been repaired. Update and photo courtesy of Pavel Kazi, FPIIB Inspector, as a part of his Sprint 2017 Inspections. (K. Fazel - UCIP) 11/10/2016 Erosion at LS toe has progressed since last inspection and is now severe. Photo courtesy of Pavel Kazi, FPIIB Inspector, as a part of his Fall 2016 Inspections. Crossing has been upgraded from Non-Urgent to Urgent. (K. Fazel - UCIP)08/20/2013 Leaky concrete standpipe on landside levee toe creating some erosion.- pump was working at the time of inspection. (P. Amatya - DWR) FIELD_STRUCT_DESC: 8-inch steel irrigation discharge pipe through the levee, invert elevation 3.7 feet below the crown. Service pole on the waterside (WS) slope. Pump on a piling structure in the stream. Concrete standpipe at the landside (LS) toe. [Additional Reference(s): DWR Levee Log, 2005. USACE Sacramento O&M Manual 112, March 1957, (RM 3.45)]. FS Date: 4/6/2017

WS view: steel pipe & pump, walkway, pump support in the channel.

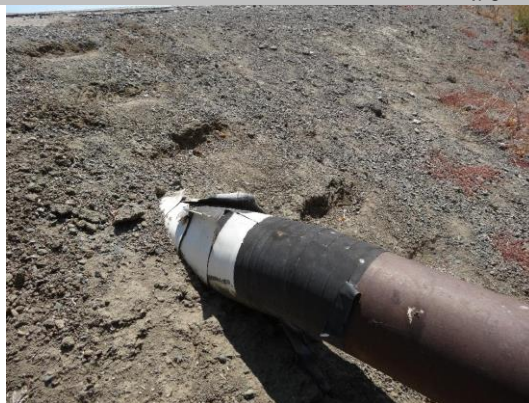
Photo 3 of 3 : UCIP_SP_2018_51467_35011.jpg

Comment Code						
Inspector Comment						
FS_ID:51467 DS_ID:22439 EP_NO: N/A Repair Type: Urgent Crossing Status: Found UCIP Comments: 03/30/2017 Riprap laid around pipe on WS slope. Source of erosion has not been addressed, nor has LS toe been repaired. Update and photo courtesy of Pavel Kazi, FPIIB Inspector, as a part of his Sprint 2017 Inspections. (K. Fazel - UCIP) 11/10/2016 Erosion at LS toe has progressed since last inspection and is now severe. Photo courtesy of Pavel Kazi, FPIIB Inspector, as a part of his Fall 2016 Inspections. Crossing has been upgraded from Non-Urgent to Urgent. (K. Fazel - UCIP)08/20/2013 Leaky concrete standpipe on landside levee toe creating some erosion.- pump was working at the time of inspection. (P. Amatya - DWR) FIELD_STRUCT_DESC: 8-inch steel irrigation discharge pipe through the levee, invert elevation 3.7 feet below the crown. Service pole on the waterside (WS) slope. Pump on a piling structure in the stream. Concrete standpipe at the landside (LS) toe. [Additional Reference(s): DWR Levee Log, 2005. USACE Sacramento O&M Manual 112, March 1957, (RM 3.45)]. FS Date: 4/6/2017

LS view: exposed pipe on levee slope.

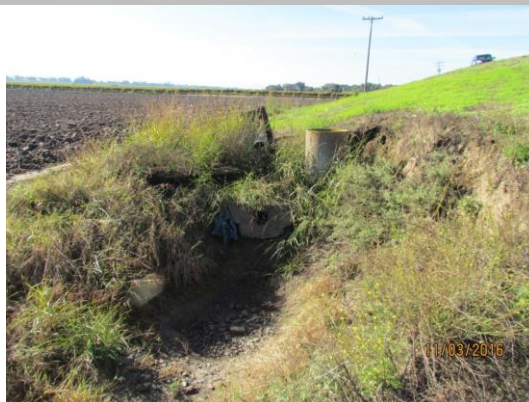
Photo 1 of 3 : SP_2018_RD0150_17_115_20180301_00124.jpg

LM Start	3.39	Rating **	U	Issue No.	115
LM End	3.39	Issue Type +	Ma	Location *	LS
Category	Earthen Levee			GPS Latitude/Longitude	
				Start	End
Item	Erosion / Bank Caving			38.363540 °	38.363540 °
				-121.555554 °	-121.555554 °
DWR ID	DWR_RD0150_03_f_2013_115				
Comment Code					
E2 : Schedule repair of erosion site prior to the next inspection.					
Inspector Comment					
Erosion (ditch) was found on the landside toe of the levee.

Updated picture of the ditch on the landside toe of the levee. Fall 2016

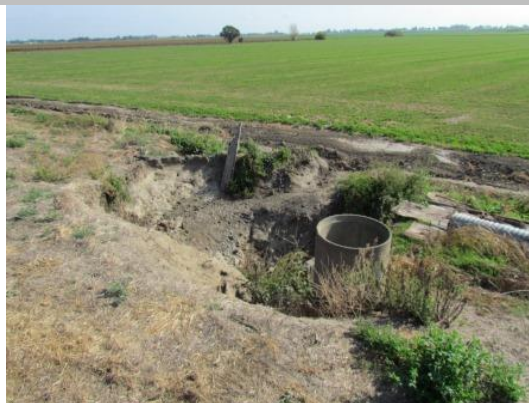
Photo 3 of 3 : SP_2018_RD0150_17_115_20180301_00126.jpg

LM Start	3.39	Rating **	U	Issue No.	115 (cont)
LM End	3.39	Issue Type +	Ma	Location *	LS

A drainage ditch with depth of 4 feet and width of 15 feet was found on the landside toe of the levee. The picture was taken from the landside slope looking upstream during the fall 2013 inspection.

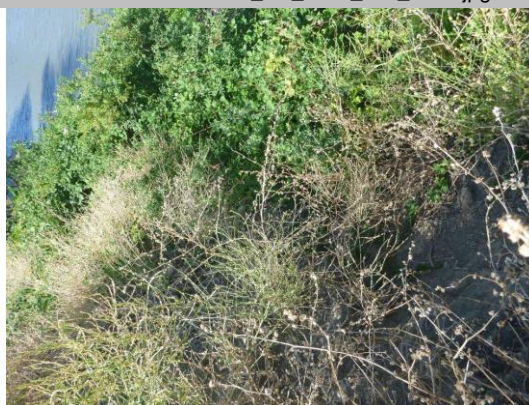
Comment Code					
Inspector Comment					
Levee Evaluation Comments					
Description:On 11 January 2017 and 7 February 2017, waterside instability and erosion were observed on the east (left) bank of Elk Slough. The site is approximately 43 feet long and 11 feet down from the levee crest. See attached pages for photos.					
Site ID No:302					
Site Designation:LMA-128					
Repair Type: Erosion					
Rating:Area of Concern					
Field Date:7/18/2017					
Notes: Erosion on lower 2/3 of slope. Crown is a paved road. Area of concern because erosion was not as severe and there was lots of vegetation on the lower slope indicating damage may be older. WS slope has been rocked just downstream of this site.

Comment Code						
Inspector Comment						
Levee Evaluation Comments						
Description:On 11 January 2017 and 7 February 2017, waterside instability and erosion were observed on the east (left) bank of Elk Slough. The site is approximately 43 feet long and 11 feet down from the levee crest. See attached pages for photos.						
Site ID No:302						
Site Designation:LMA-128						
Repair Type: Erosion						
Rating:Area of Concern						
Field Date:7/18/2017						
Notes: Erosion on lower 2/3 of slope. Crown is a paved road. Area of concern because erosion was not as severe and there was lots of vegetation on the lower slope indicating damage may be older. WS slope has been rocked just downstream of this site.

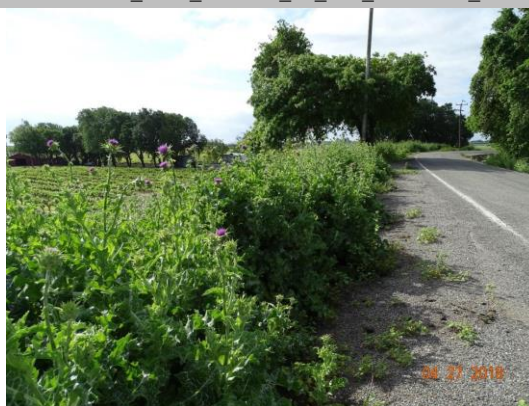
Photo 1 of 1 : SP_2018_RD0150_17_106_20180430_00200.jpg

LM Start	3.93	Rating **	U	Issue No.	106
LM End	3.94	Issue Type +	Ma	Location *	LS
Category	Earthen Levee			GPS Latitude/Longitude	
				Start	End
Item	Vegetation			38.368874 °	38.369025 °
				-121.551369 °	-121.551401 °
DWR ID	DWR_RD0150_03_s_2018_106				
Comment Code					
V2 : Remove the wild growth other than native grasses from the levee slopes.					
Inspector Comment

Vegetation landside looking south.

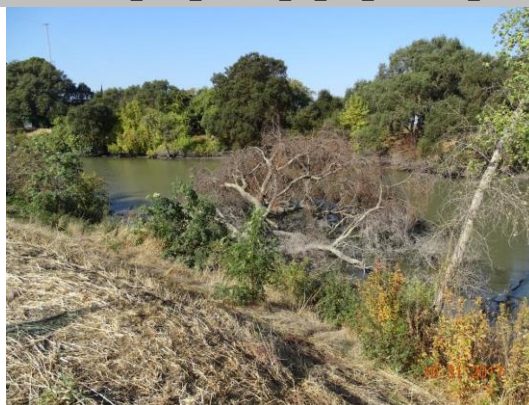
Photo 1 of 1 : SP_2018_RD0150_17_126_20180301_00145.jpg

LM Start	4.36	Rating **	A/W	Issue No.	126
LM End	4.36	Issue Type +	Ma	Location *	WS
Category	Earthen Levee			GPS Latitude/Longitude	
				Start	End
Item	Encroachments			38.374191 °	38.374191 °
				-121.549818 °	-121.549818 °
DWR ID	DWR_RD0150_03_f_2017_126				
Comment Code					
TR : Tree or limb					
Inspector Comment					
A tree fell on the channel, and tree root might erode the waterside toe of the levee.

View of a fallen tree on the waterside toe of the levee.

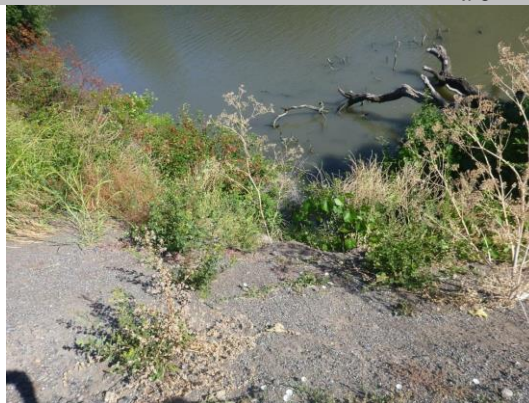
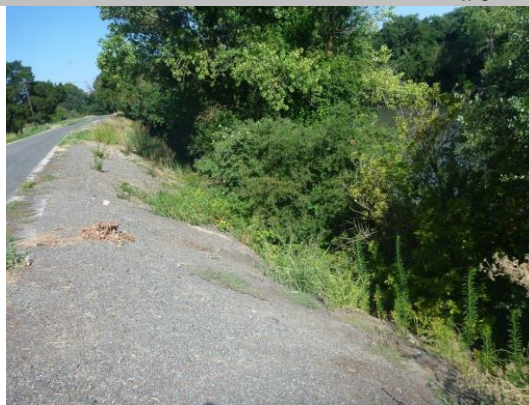
Photo 1 of 2 : LEVAL_SP_2018_305_2066.jpg

Comment Code					
Inspector Comment					
Levee Evaluation Comments					
Description:Between 11 January 2017 and 7 February 2017, instability, cracking, and erosion of the waterside levee slope were observed on the east (left) bank of Elk Slough. The site is approximately 88 feet long. See attached pages for photos.					
Site ID No:305					
Site Designation:LMA-131					
Repair Type: Erosion					
Rating:Serious					
Field Date:7/18/2017					
Notes: Crown is a paved road. Near vertical sloughing on the lower 2/3 of the prism. House and ramp/driveway on the LS. Serious because sloughing cuts into already oversteepened prism significantly.

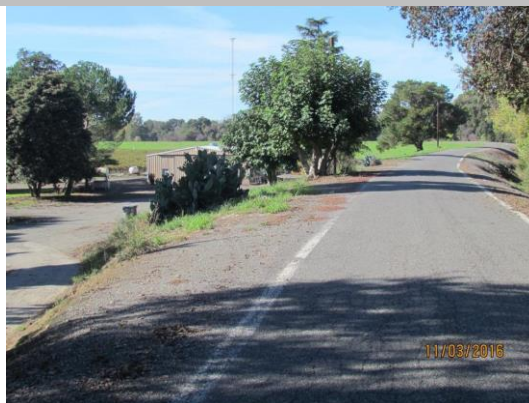
Photo 1 of 1 : SP_2018_RD0150_17_94_20180301_00096.jpg

LM Start	4.49	Rating **	M	Issue No.	94
LM End	4.49	Issue Type +	En	Location *	LS
Category	Earthen Levee			GPS Latitude/Longitude	
				Start	End
Item	Vegetation			38.374367 °	38.374367 °
				-121.547327 °	-121.547327 °
DWR ID	DWR_RD0150_03_s_2012_94				
Comment Code					
V6 : Landscaping					
Inspector Comment

View of landscape on the landside shoulder of the levee.

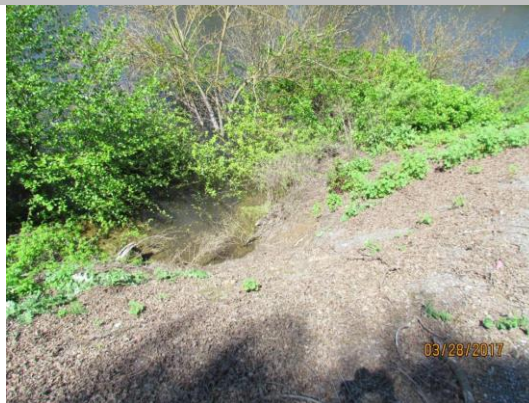
Photo 1 of 1 : SP_2018_RD0150_17_101_20180301_00104.jpg

LM Start	4.79	Rating **	M	Issue No.	101
LM End	4.79	Issue Type +	Ma	Location *	WS
Category	Earthen Levee			GPS Latitude/Longitude	
				Start	End
Item	Erosion / Bank Caving			38.376562 °	38.376562 °
				-121.543016 °	-121.543016 °
DWR ID	DWR_RD0150_03_s_2017_101				
Comment Code					
E2 : Schedule repair of erosion site prior to the next inspection.					
Inspector Comment

View of an erosion on the waterside toe of the levee.

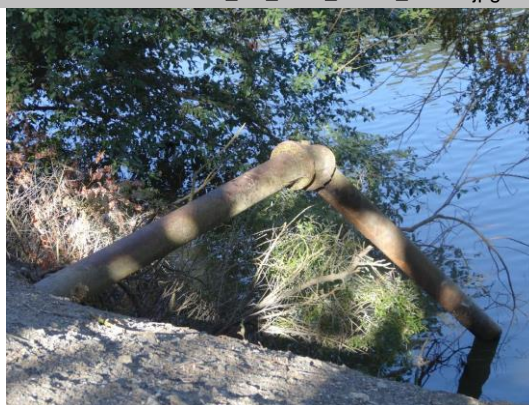
Photo 1 of 3 : UCIP_SP_2018_19283_32565.jpg

LM Start	4.90	Rating **	M	Issue No.	958
LM End	4.90	Issue Type +	En	Location *	
Category	Supplemental			GPS Latitude/Longitude	
				Start	End
Item	DWR UCIP Field Study			38.377718 °	38.377718 °
				-121.541413 °	-121.541413 °
DWR ID					
Comment Code					
Inspector Comment					
FS_ID:19283 DS_ID:22445 EP_NO: N/A Repair Type: Non-Urgent Crossing Status: Found UCIP Comments: - seems abandoned.- may need proper abandonment FIELD_STRUCT_DESC: *ABANDONED* 10-inch steel irrigation discharge pipe through the levee, invert elevation 7.2 feet below the crown. Gate valve on the landside (LS) end. (D. Conner). [Additional Reference(s): DWR Levee Log, 2005. USACE Sacramento O&M Manual 112, March 1957, (HLM 4.99)]. FS Date: 8/23/2013

WS view: steel pipe on levee slope and in the stream.

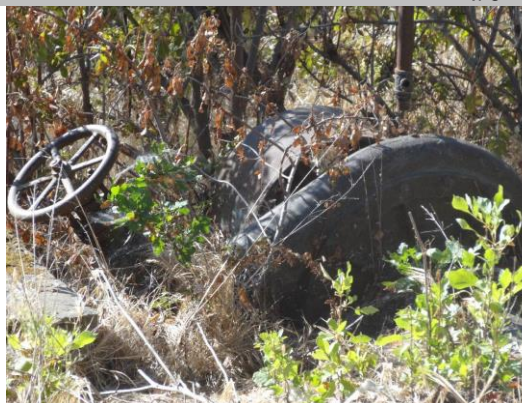
Photo 3 of 3 : UCIP_SP_2018_19283_32563.jpg

LM Start	4.90	Rating **	M	Issue No.	958 (cont)	
LM End	4.90	Issue Type +	En	Location *		
Category	Supplemental			GPS Latitude/Longitude		
				Start		End
Item	DWR UCIP Field Study			38.377718 °		38.377718 °
				-121.541413 °		-121.541413 °
DWR ID						
Comment Code						
Inspector Comment						
FS_ID:19283 DS_ID:22445 EP_NO: N/A Repair Type: Non-Urgent Crossing Status: Found UCIP Comments: - seems abandoned.- may need proper abandonment FIELD_STRUCT_DESC: *ABANDONED* 10-inch steel irrigation discharge pipe through the levee, invert elevation 7.2 feet below the crown. Gate valve on the landside (LS) end. (D. Conner). [Additional Reference(s): DWR Levee Log, 2005. USACE Sacramento O&M Manual 112, March 1957, (HLM 4.99)]. FS Date: 8/23/2013

LS view: abandoned pump and gate valve on levee slope.

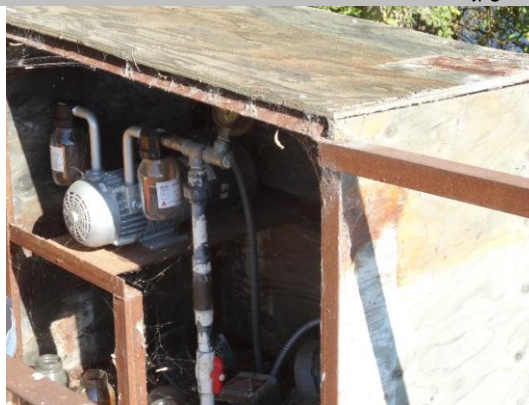
Photo 2 of 3 : UCIP_SP_2018_49386_63901.jpg

FS_ID:49386
DS_ID:22446
EP_NO: N/A
Repair Type: No Action Needed
Crossing Status: Found
UCIP Comments: 5/2014 Recordation from permit files 13736 match photos and approximate location of UCIP confirmed crossing. 8/2013- a smaller pump on WS steel deck and was running.- seems 30-inch steel pipe goes through the levee.- GI electric conduit on WS and power pole on LS.
FIELD_STRUCT_DESC: 24-inch steel drainage discharge pipe through the levee, 10.5 feet below the crown. Flap gate on the waterside (WS) end. Pump and gate valve at the landside (LS) toe. (Plans to install a 24-inch discharge pipeline through the levee authorized under Permit No. 13736, 1983 - Reclamation District No. 150 [RD0150]). [Additional Reference(s): DWR Levee Log, 2005. USACE Sacramento O&M Manual 112, March 1957, (HLM 5.15), 30-inch pipe referenced, invert elevation 14.5 feet below the crown].
FS Date: 8/23/2013

WS view: a smaller pump on steel deck. It was working during the survey.

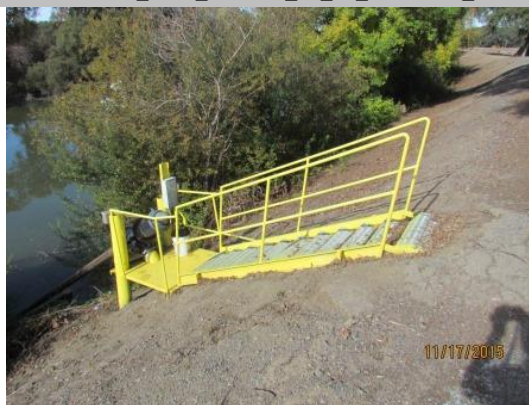
Photo 1 of 1 : SP_2018_RD0150_17_48_20180301_00042.jpg

LM Start	5.09	Rating **	M	Issue No.	48
LM End	5.09	Issue Type +	En	Location *	WS
Category	Earthen Levee			GPS Latitude/Longitude	
				Start	End
Item	Encroachments			38.380110 °	38.380110 °
				-121.540061 °	-121.540061 °
DWR ID	DWR_RD0150_03_f_2015_48				
Comment Code					
ST : Stairway					
Inspector Comment					
Unpermitted stairway.

View of a stairway on the waterside of the levee.

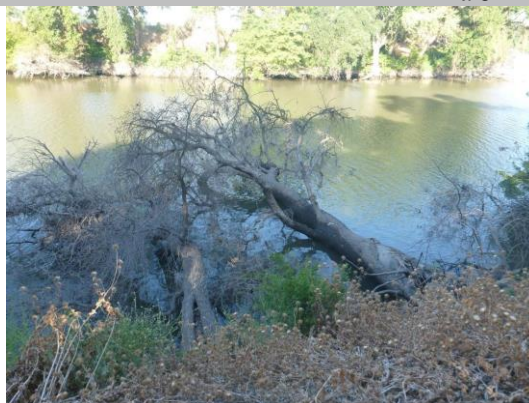
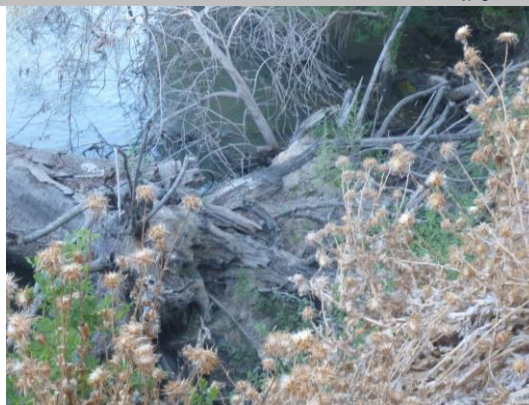
Photo 1 of 3 : LEVAL_SP_2018_309_2036.jpg

Comment Code					
Inspector Comment					
Levee Evaluation Comments					
Description:On 19 January 2017, two large trees were observed to have fallen into the water exposing the root ball on the waterside levee slope on the east (left) bank of Elk Slough. The site is approximately 10 feet long. See attached pages for photos.					
Site ID No:309					
Site Designation:LMA-135					
Repair Type: Erosion					
Rating:Area of Concern					
Field Date:7/18/2017					
Notes: 2 oak trees fell over at the WS toe and took root balls out of the lower slope about 5 ft deep just above the water line. Area of concern because damage is only on the lower slope near the water line.

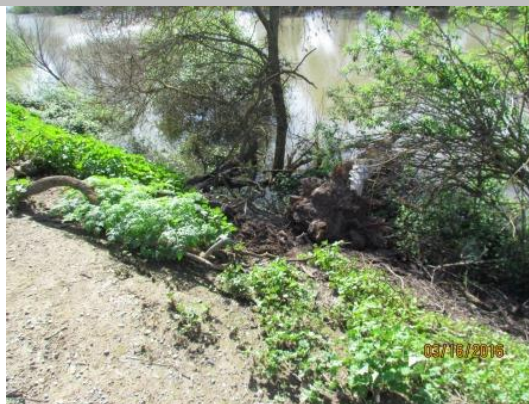
Photo 1 of 1 : SP_2018_RD0150_17_96_20180301_00098.jpg

LM Start	5.32	Rating **	M	Issue No.	96	
LM End	5.32	Issue Type +	Ma	Location *	WS	
Category	Earthen Levee			GPS Latitude/Longitude		
				Start		End
Item	Encroachments			38.381843 °		38.381843 °
				-121.543117 °		-121.543117 °
DWR ID	DWR_RD0150_03_s_2016_96					
Comment Code						
TR : Tree or limb						
Inspector Comment						
Broken tree/root damaged levee slope.

Broken tree roots and tree trunks were found on the waterside toe of the levee.

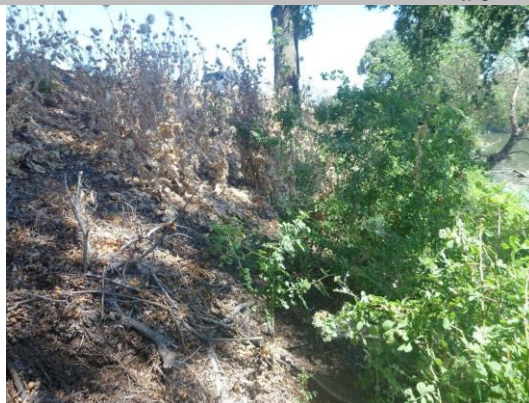
Photo 1 of 3 : LEVAL_SP_2018_310_2188.jpg

Comment Code					
Inspector Comment					
Levee Evaluation Comments					
Description:Cracking and erosion were observed on the waterside levee slope on the east (left) bank of Elk Slough. The site is approximately 40 feet long. See attached pages for photos.					
Site ID No:310					
Site Designation:LMA-136					
Repair Type: Erosion					
Rating:Serious					
Field Date:7/17/2017					
Notes: Large oak tree fell over here and took a root ball with it. At least 15 ft wide by 5ft deep soil missing, 5 ft from crown. Longitudinal cracks for 40 ft along crown hinge. Serious because prism is impacted and cracking is visible beyond the damaged area.

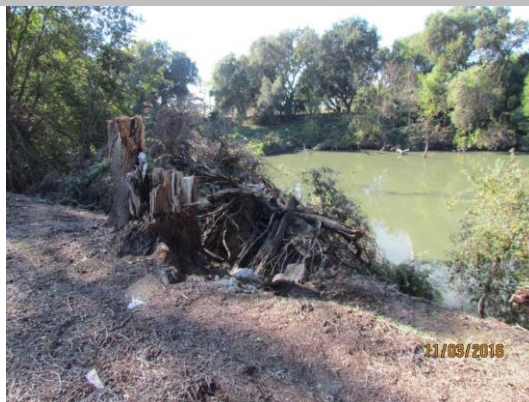
Photo 1 of 1 : SP_2018_RD0150_17_74_20180301_00071.jpg

LM Start	5.49	Rating **	N	Issue No.	74
LM End	5.49	Issue Type +	Ma	Location *	WS
Category	Earthen Levee			GPS Latitude/Longitude	
				Start	End
Item	Trim / Thin Trees			38.383051 °	38.383051 °
				-121.545735 °	-121.545735 °
DWR ID	DWR_RD0150_03_f_2016_74				
Comment Code					
T5 : Tree stumps.					
Inspector Comment					
Tree stump and broken tree was found on the waterside shoulder of the levee.

View of tree trunks on the waterside shoulder of the levee. Fall 2016

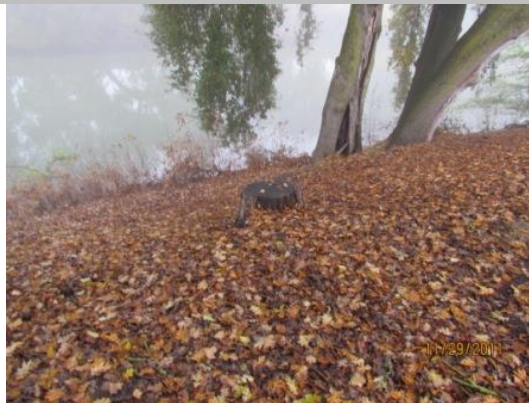
Photo 1 of 1 : SP_2018_RD0150_17_68_20180301_00066.jpg

LM Start	5.56	Rating **	N	Issue No.	68
LM End	5.56	Issue Type +	Ma	Location *	WS
Category	Earthen Levee			GPS Latitude/Longitude	
				Start	End
Item	Trim / Thin Trees			38.383697 °	38.383697 °
				-121.545201 °	-121.545201 °
DWR ID	DWR_RD0150_03_s_2012_68				
Comment Code					
T5 : Tree stumps.					
Inspector Comment

Tree stump was found on the waterside of the levee looking upstream.

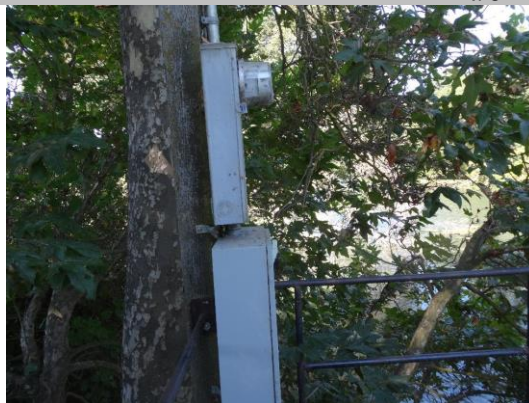
Photo 2 of 3 : UCIP_SP_2018_28265_51973.jpg

Comment Code						
Inspector Comment						
FS_ID:28265						
DS_ID:22448						
EP_NO: N/A						
Repair Type: Non-Urgent						
Crossing Status: Found						
UCIP Comments: - levee toe cut out at open end of the pipe.- service pole and control box on river bank.						
FIELD_STRUCT_DESC: 10-inch steel irrigation discharge pipe through the levee, invert elevation 7.8 feet below the crown. Pump and gate valve on a steel platform on the waterside (WS). (Plans for the installation of a vertical unit irrigation pumping plant and a 10-inch, 10-gauge steel discharge pipe through the levee authorized under Permit No. 1167, 1947 - Darrell Connor). [Additional Reference(s): DWR Levee Log, 2005. USACE Sacramento O&M Manual 112, March 1957, (HLM 5.80)].						
FS Date: 8/23/2013

WS view: electric control box and power pole.

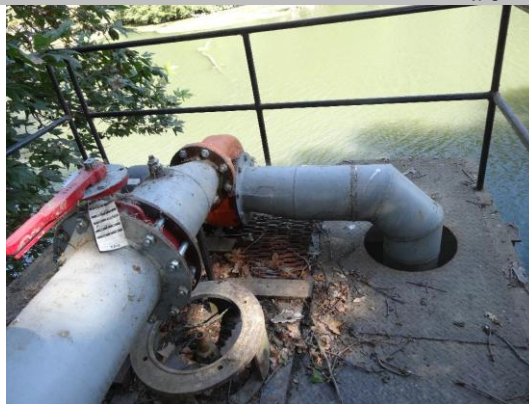
Photo 3 of 3 : UCIP_SP_2018_28265_51972.jpg

LM Start	5.70	Rating **	M	Issue No.	960 (cont)
LM End	5.70	Issue Type +	En	Location *

WS view: pipe. pump and gate valve on pump deck.

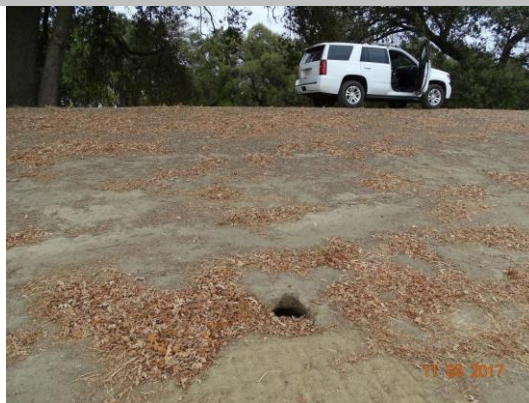
Photo 1 of 1 : SP_2018_RD0150_17_127_20180301_00146.jpg

LM Start	5.73	Rating **	M	Issue No.	127
LM End	5.73	Issue Type +	Ma	Location *	LS
Category	Earthen Levee			GPS Latitude/Longitude	
				Start	End
Item	Animal Control			38.384061 °	38.384061 °
				-121.542169 °	-121.542169 °
DWR ID	DWR_RD0150_03_f_2017_127				
Comment Code					
A3 : No rodents visible, but rodent burrows visible; need to backfill and compact or grout burrows.					
Inspector Comment

View of a rodent hole on the landside slope of the levee. Fall 2017

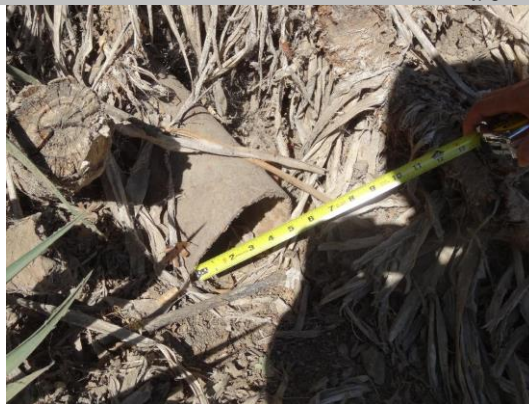
Photo 3 of 3 : UCIP_SP_2018_19403_32943.jpg

LS view: open end steel pipe on levee toe.

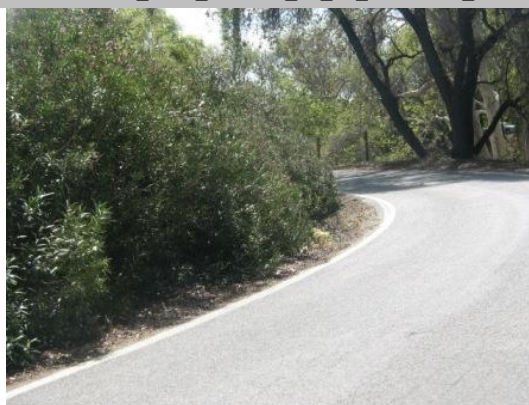
Photo 1 of 1 : SP_2018_RD0150_17_24_20180301_00009.jpg

LM Start	6.13	Rating **	U	Issue No.	24
LM End	6.20	Issue Type +	En	Location *	LS
Category	Earthen Levee			GPS Latitude/Longitude	
				Start	End
Item	Vegetation			38.388535 °	38.389391 °
				-121.541657 °	-121.541901 °
DWR ID	DWR_RD0150_03_s_2012_24				
Comment Code					
V6 : Landscaping					
Inspector Comment

Oleander on landward slope blocking view of levee.

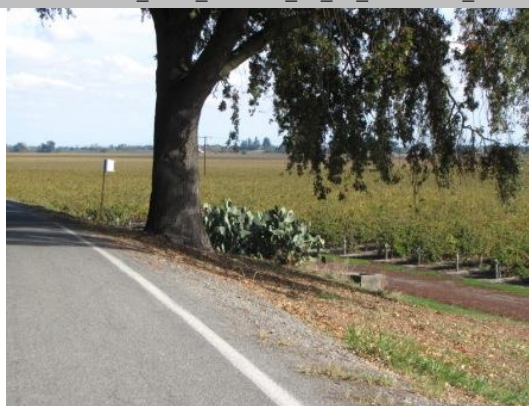
Photo 1 of 1 : SP_2018_RD0150_17_60_20180301_00056.jpg

LM Start	6.45	Rating **	M	Issue No.	60
LM End	6.45	Issue Type +	En	Location *	LS
Category	Earthen Levee			GPS Latitude/Longitude	
				Start	End
Item	Vegetation			38.391616 °	38.391616 °
				-121.538378 °	-121.538378 °
DWR ID	DWR_RD0150_03_s_2012_60				
Comment Code					
V6 : Landscaping					
Inspector Comment

View of landscaping along the landward slope.

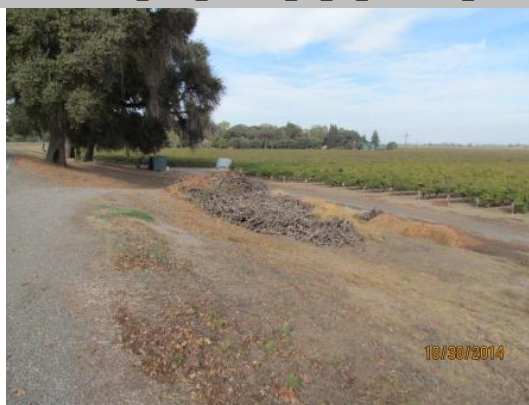
Photo 1 of 1 : SP_2018_RD0150_17_83_20180301_00083.jpg

LM Start	6.52	Rating **	M	Issue No.	83
LM End	6.52	Issue Type +	En	Location *	LS
Category	Earthen Levee			GPS Latitude/Longitude	
				Start	End
Item	Encroachments			38.392580 °	38.392580 °
				-121.538059 °	-121.538059 °
DWR ID	DWR_RD0150_03_f_2014_83				
Comment Code					
PR : Prunings					
Inspector Comment

Prunings were found on the landside toe of the levee looking upstream.

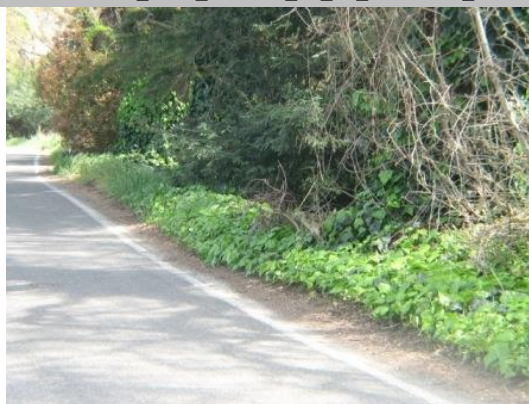
Photo 1 of 1 : SP_2018_RD0150_17_30_20180301_00013.jpg

LM Start	6.78	Rating **	U	Issue No.	30
LM End	6.80	Issue Type +	En	Location *	LS
Category	Earthen Levee			GPS Latitude/Longitude	
				Start	End
Item	Vegetation			38.395791 °	38.395869 °
				-121.537399 °	-121.537101 °
DWR ID	DWR_RD0150_03_s_2012_30				
Comment Code					
V6 : Landscaping					
Inspector Comment

Landscaping on landward slope blocking view from LM 6.87 to 6.95

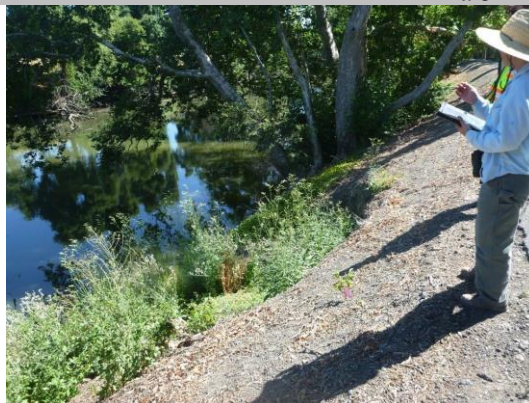
Photo 1 of 3 : LEVAL_SP_2018_312_2310.jpg

LM Start	6.79	Rating **	A/W	Issue No.	119
LM End	6.80	Issue Type +	Ma	Location *	
Category	Supplemental			GPS Latitude/Longitude	
				Start	End
Item	2017 Storm Damage			38.395833 °	38.395850 °
				-121.537150 °	-121.537083 °
DWR ID	DWR_RD0150_03_f_2017_119				
Comment Code					
Inspector Comment					
Levee Evaluation Comments					
Description:On 10 February 2017, instability, cracking, and sloughing of the waterside levee slope were observed on the east (left) bank of Elk Slough. The site is approximately 20 feet long. See attached pages for photos.					
Site ID No:312					
Site Designation:LMA-139					
Repair Type: Stability					
Rating:Critical					
Field Date:7/19/2017					
Notes: Crown is paved. Serious because erosion cuts into prism significantly, but not into crown. Worst damage is above a fallen tree, sloughing comes within 6 ft of crown here.

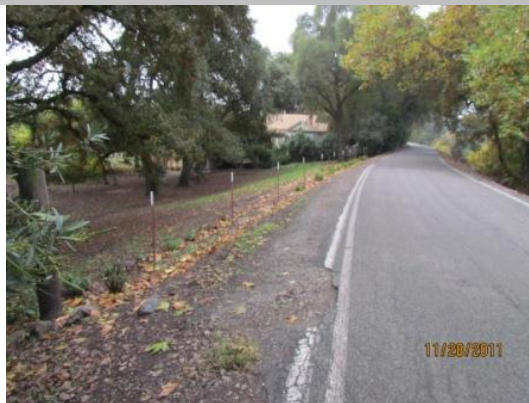
Photo 1 of 1 : SP_2018_RD0150_17_13_20180301_00005.jpg

LM Start	6.82	Rating **	M	Issue No.	13
LM End	6.93	Issue Type +	En	Location *	LS
Category	Earthen Levee			GPS Latitude/Longitude	
				Start	End
Item	Encroachments			38.395998 °	38.395470 °
				-121.536613 °	°
DWR ID	DWR_RD0150_03_s_2012_13				
Comment Code					
FE : Fence					
Inspector Comment

Fence was found on the landside of the levee looking downstream.

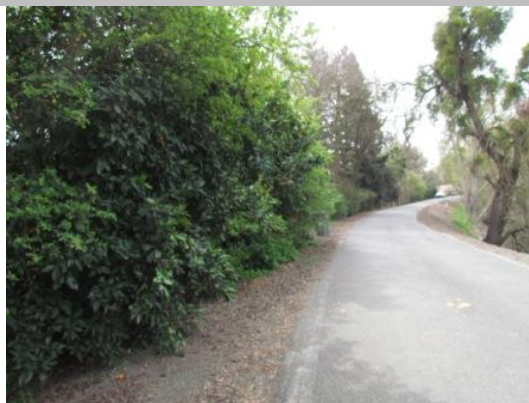
Photo 1 of 1 : SP_2018_RD0150_17_933_20180301_00149.jpg

LM Start	6.85	Rating **	U	Issue No.	933
LM End	6.93	Issue Type +	En	Location *	LS
Category	Earthen Levee			GPS Latitude/Longitude	
				Start	End
Item	Vegetation			38.396187 °	38.396989 °
				-121.536180 °	-121.535151 °
DWR ID	DWR_RD0150_03_s_2012_933				
Comment Code					
V6 : Landscaping					
Inspector Comment					
Landscaping has been maintained better, but some obstructions still exist.

View of the landscape on the landside shoulder of the levee looking downstream.

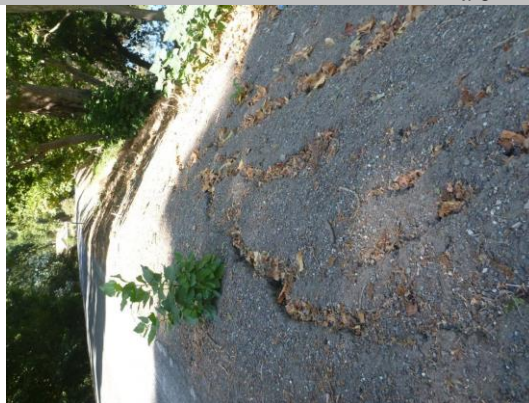
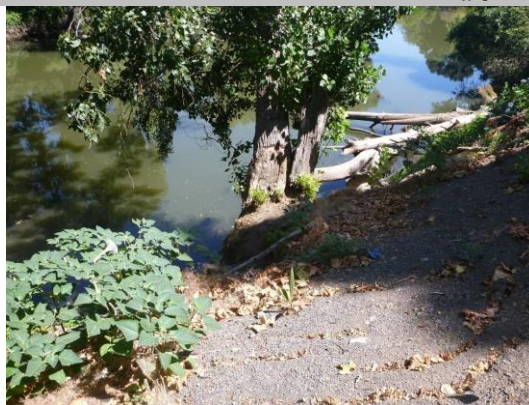
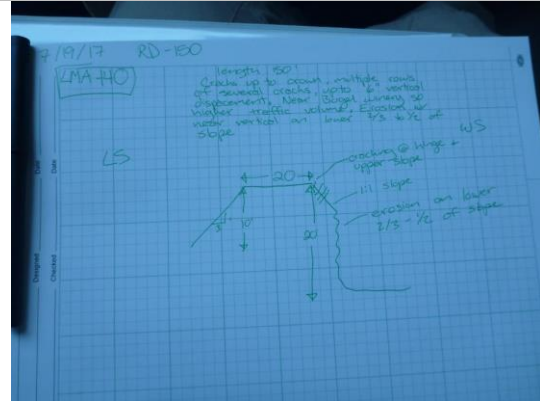
LM Start	6.86	Rating **	M	Issue No.	120
LM End	6.87	Issue Type +	Ma	Location *	
Category	Supplemental			GPS Latitude/Longitude	
				Start	End
Item	2017 Storm Damage			38.396233 °	38.396294 °
				-121.536064 °	-121.535947 °
DWR ID	DWR_RD0150_03_f_2017_120				
Comment Code					
Inspector Comment					
Levee Evaluation Comments					
Description:On 10 February 2017, instability, cracking, and sloughing of the waterside levee slope were observed on the east (left) bank of Elk Slough. The site is approximately 40 feet long. See attached pages for photos.					
Site ID No:313					
Site Designation:LMA-140					
Repair Type: Stability					
Rating:Critical					
Field Date:7/19/2017					
Notes: Crown is a paved road. Serious because of extensive cracking up to hinge, high traffic volume due to nearby winery and lower 2/3 - 1/2 of slope is near vertical.
